IR Thermography In The Building Science Industry

Scott Wood & Bill Weber

Four Star Cleaning and Restoration, Inc. a Disaster Kleenup International Member

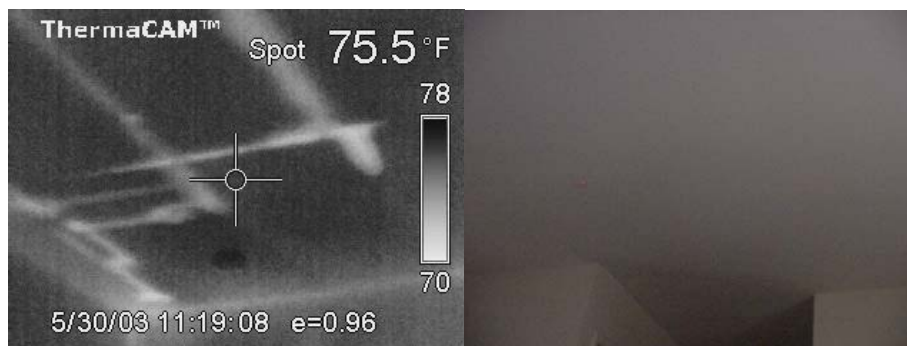
Figure 1. Thermogram/photo pair showing moisture detected on a ceiling (lighter areas).

Figure 1 shows the infrared image of the ceiling after the test. The lighter images indicate cooler wet sheetrock. A non-destructive moisture meter was used to confirm the presence of moisture where indicated by the IR imaging. At the beginning of the water test, moisture intrusion was visible beginning at the edge of the ceiling and not in the center of the ceiling where the water staining was first visible.

Further examination of the areas above the room revealed a failed door threshold just above the discovered intrusion point. Without the infrared camera we would have first removed the ceiling of the bedroom at the location of the water stain to pinpoint the water intrusion point. Because the actual leak was not directly above the stain it would have been difficult to pinpoint the source. When using the IR camera in conjunction with the water test we were able to pinpoint the water source without needing to open the ceiling, and possibly missing the entry point altogether.

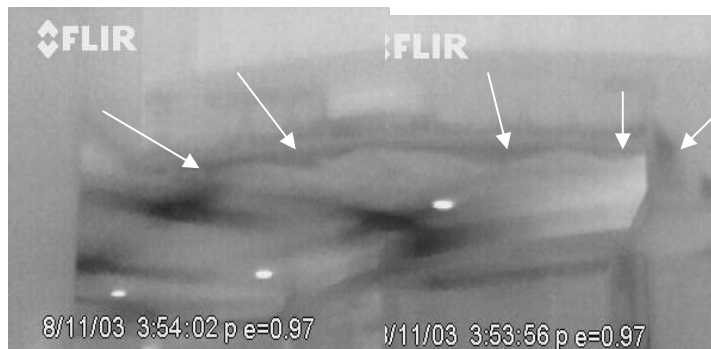
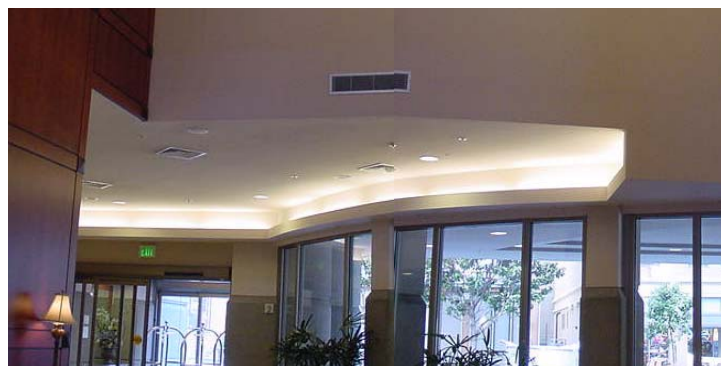
A water pipe broke on the third floor of a hotel, sending water throughout the third floor and the two floors below. Four Star's water division was called to perform emergency services on the water-damaged structure. A quick IR camera survey of the three floors was performed allowing for a quick determination of the affected areas to evaluate swift and efficient placement of drying equipment. One area of the hotel that was of concern was the lobby ceiling. The ceiling was at a height and location that prohibited direct moisture testing using standard non-destructive and penetrating moisture meters. Ladders would have blocked entry and the procedure would have required a considerable length of time to adequately survey the whole lobby ceiling. As shown in Figure 2, within minutes moisture was located in the lobby's ceiling using the thermal imaging camera. Because the specific areas of the ceiling could be determined so quickly and precisely, we were able to place drying equipment only in the areas needed to safely dry the areas involved.

Figure 2. Thermogram/photo pair showing moisture detected on the ceiling of a hotel lobby.

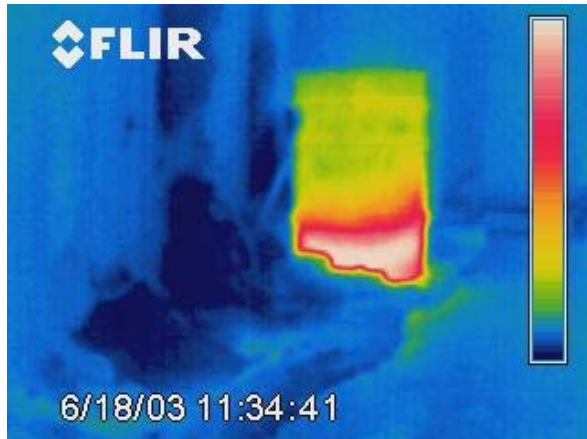
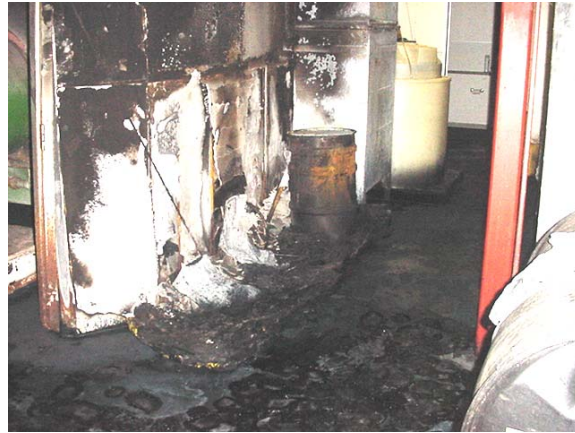
Fire occurred at a garment dying facility. We were called to perform emergency services and were on-site about 10 hours after the fire was knocked down. An infrared thermographic inspection revealed a potentially explosive drum of sodium hydrosulfite that was still hot hours after the fire was extinguished. Figure 3 shows the 32-gallon drum still sitting in the ashes of the fire. Water reacts with sodium hydrosulfite to produce poisonous hydrogen sulfide gas, and enough heat to cause spontaneous combustion and a potential explosion in the sealed container. A hazardous waste hauler, the fire department, and HAZMAT were called and disposed of the drum, preventing a possible catastrophe.

Figure 3. Thermogram/photo showing the heated sodium hydrosulfite in a 32 gallon drum.
